FATAL ACCIDENT REPORT

LEECO, INCORPORATED MINE NUMBER 68 (67)

MACHINERY ACCIDENT

STATE FILE NO. 11305-53

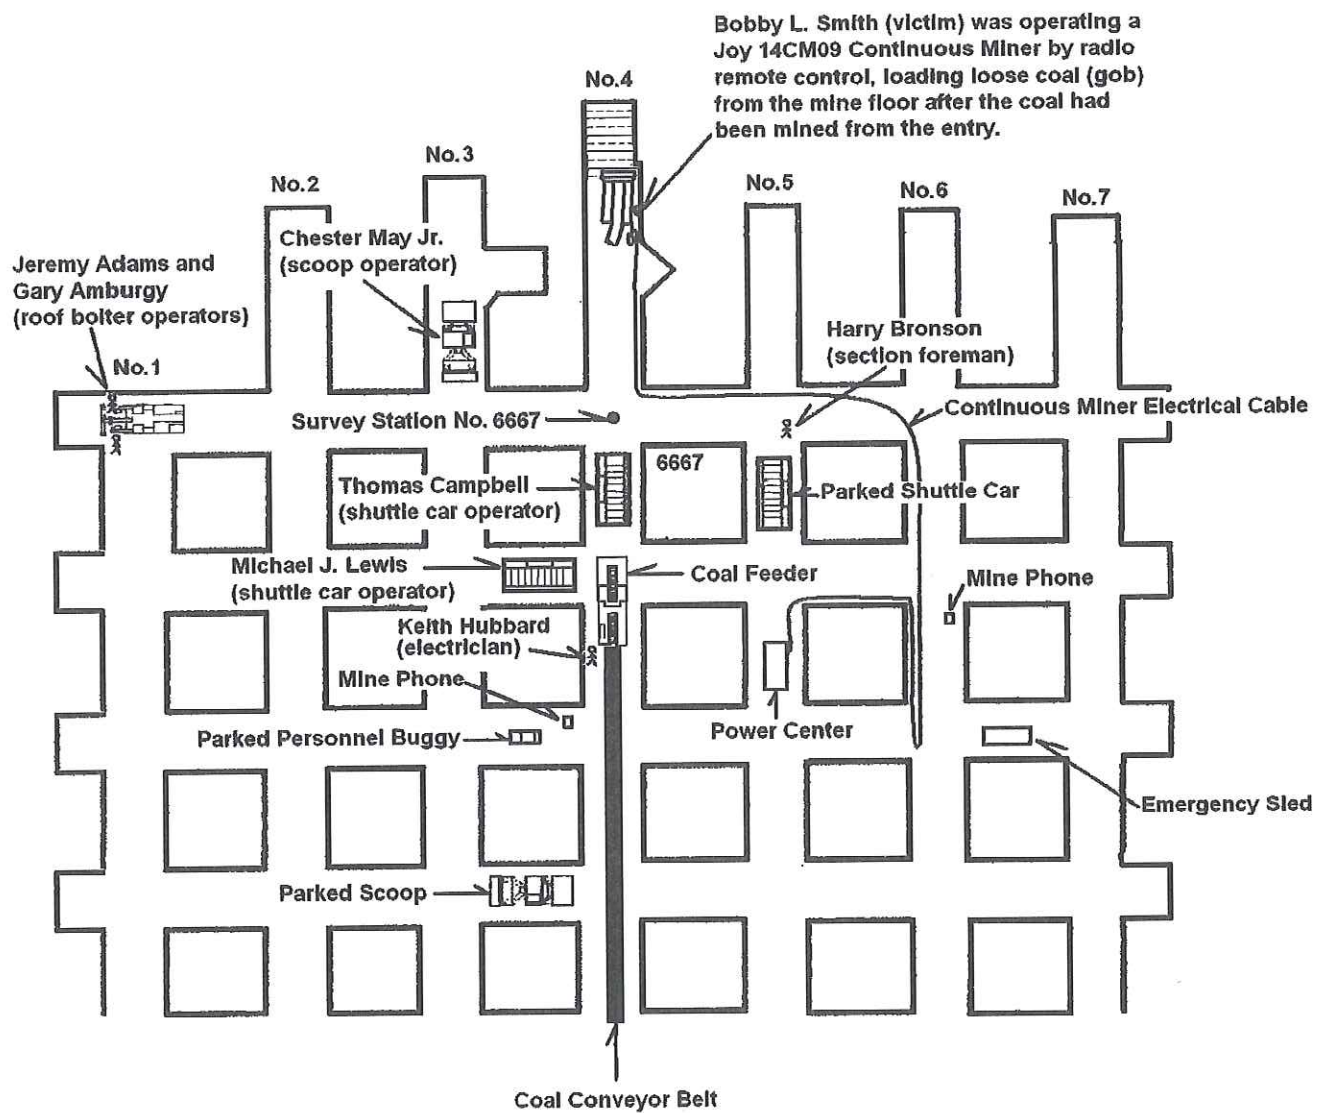
Sketch No. 1
Before The Accident
Not To Scale

The 014 Section
Accident Scene - No. 4 Entry

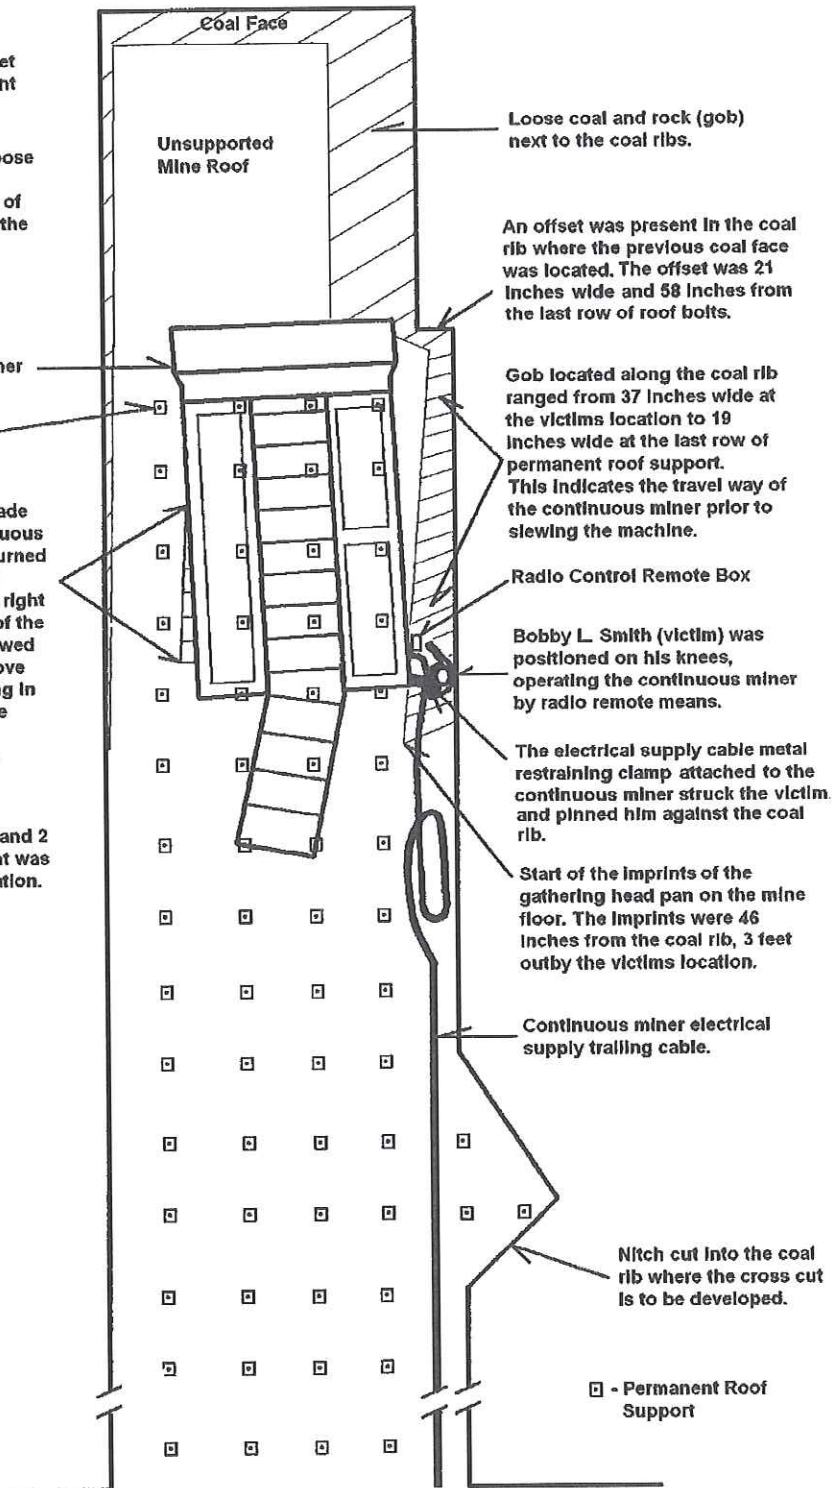
Sketch No. 2
 After The Accident
 Not To Scale

The cut depth averaged 25 feet from the last row of permanent roof support.

The victim had cleaned the loose coal from the left side of the entry and was in the process of cleaning the right side when the accident occurred.

Imprints on the mine floor made by the left track of the continuous miner indicate the machine turned or slewed 17 inches to avoid contact with the offset in the right coal rib by the cutting head of the machine. This maneuver allowed the rear of the machine to move more than 30 inches, resulting in the victim being struck by the electrical supply cable metal restraining clamp (stand off).

The entry width was 19 feet and 2 inches and the overall height was 71 inches at the victims location.

1. During mining and place changing with remote control miners, all persons shall be positioned in an area that will afford maximum protection to themselves and others from moving equipment.
2. Mine management shall review the red zone restricted areas with all mine personnel.

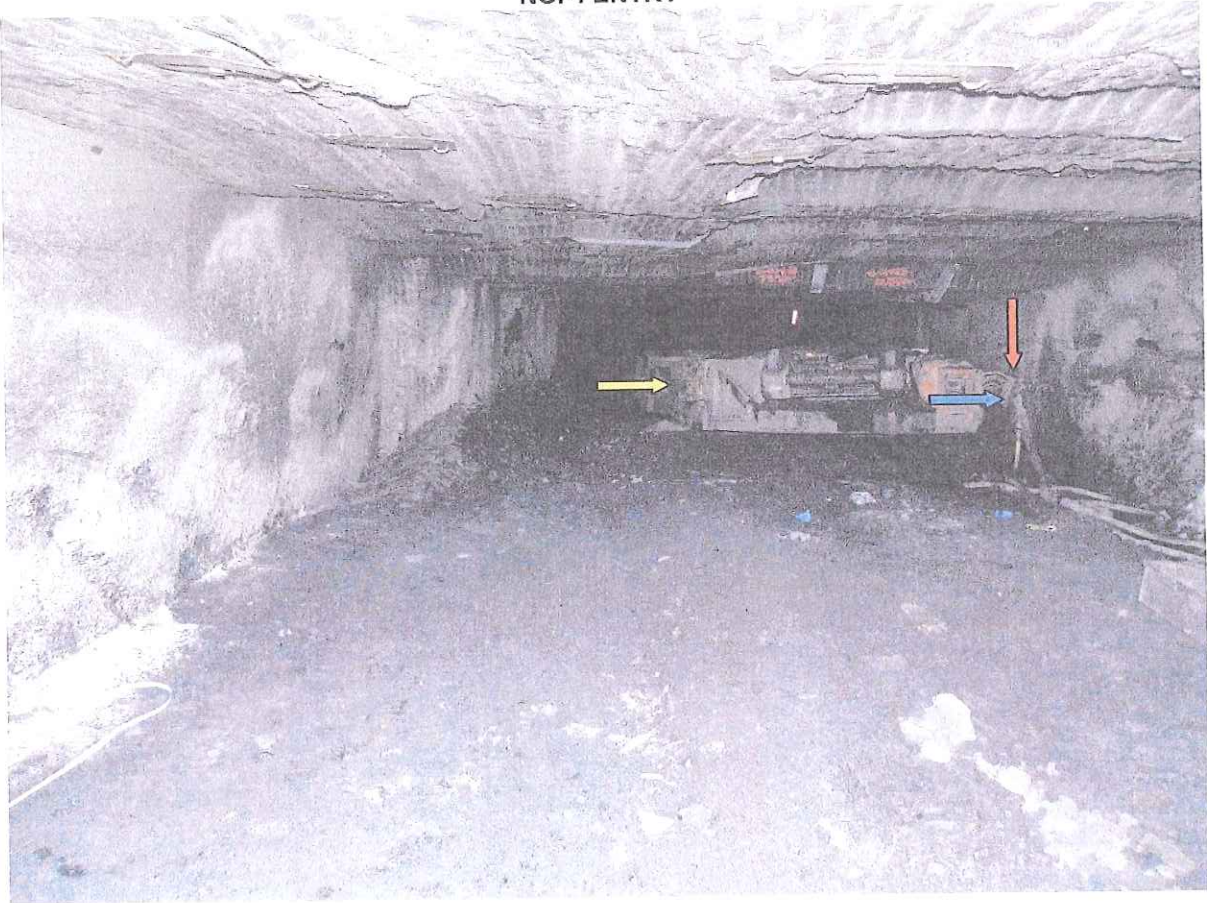
ACCIDENT SCENE
NO. 4 ENTRY

The metal restraining clamp (stand-off), located on the right side, extended twelve (12) inches away from the frame of the machine. The restraining clamp struck the victim's torso and pinned him against the right coal rib.

RED ARROW INDICATES THE APPROXIMATE LOCATION OF THE VICTIM, BOBBY L. SMITH

YELLOW ARROW INDICATES THE CONTINUOUS MINER

BLUE ARROW INDICATES THE ELECTRICAL SUPPLY CABLE'S
METAL RESTRAINING CLAMP (ATTACHED TO THE CONTINUOUS MINER);
THE CLAMP STRUCK THE VICTIM AND PINNED HIM AGAINST THE COAL RIB

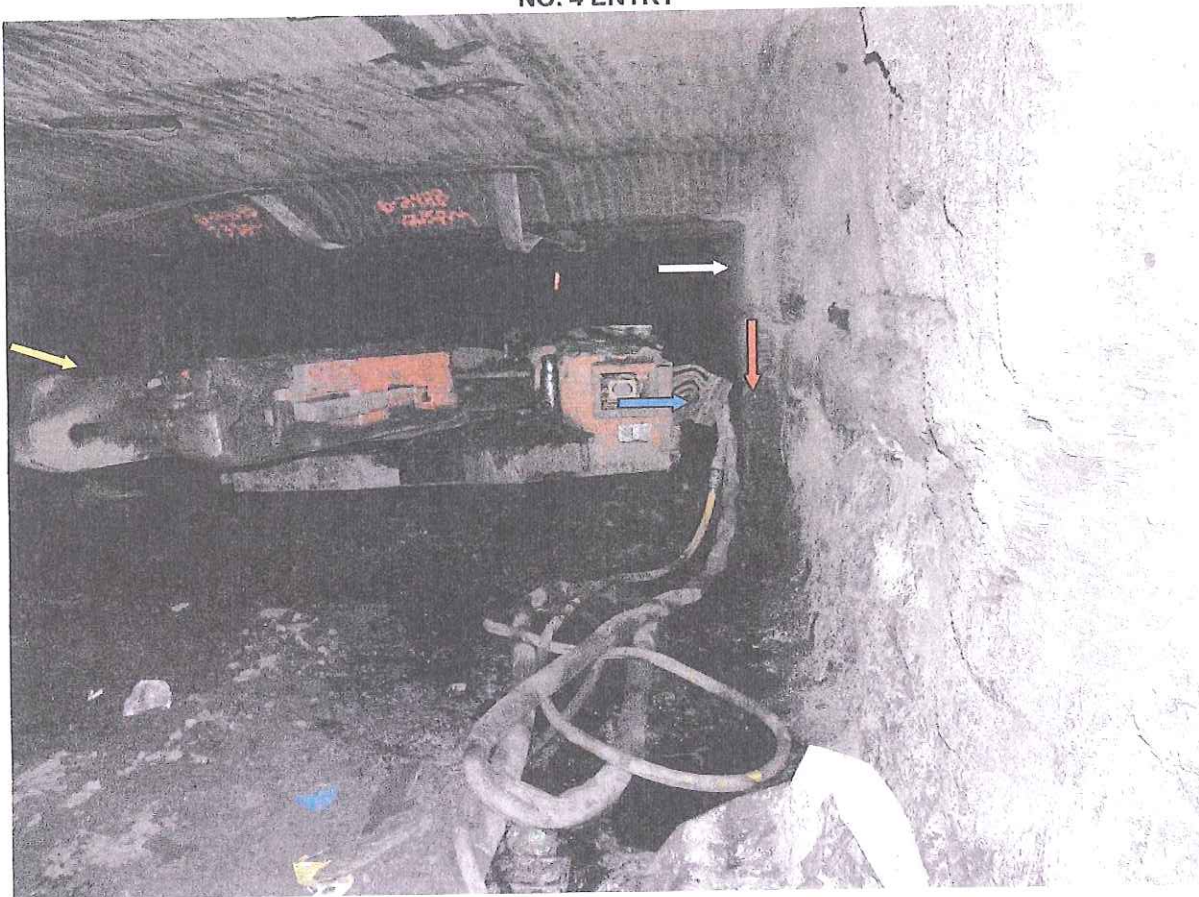
ACCIDENT SCENE
NO. 4 ENTRY

Due to the entry being slightly off center, an offset of the coal rib was present on the right side. The offset protruded into the entry twenty-one (21) inches and was part of the previous coal face. The offset was twenty (20) feet and ten (10) inches from where the victim was found, on the right rib.

Imprints and marks on the floor indicate that Smith trammed the continuous miner toward the offset, but he turned (slewed) the front of the machine to the left to avoid hitting it with the cutting head. Imprints made by the machine's metal tracks on the mine floor measured seventeen (17) inches where it turned or slewed. This maneuver allowed the rear of the machine, where the restraining clamp (stand-off) is located, to move approximately thirty inches (30) inches toward the victim.

RED ARROW INDICATES THE APPROXIMATE LOCATION OF THE VICTIM, BOBBY L. SMITH

YELLOW ARROW INDICATES THE CONTINUOUS MINER

BLUE ARROW INDICATES THE ELECTRICAL SUPPLY CABLE'S
METAL RESTRAINING CLAMP (ATTACHED TO THE CONTINUOUS MINER);
THE CLAMP STRUCK THE VICTIM AND PINNED HIM AGAINST THE COAL RIB

WHITE ARROW INDICATES AN OFFSET THAT WAS PRESENT IN THE RIGHT COAL RIB

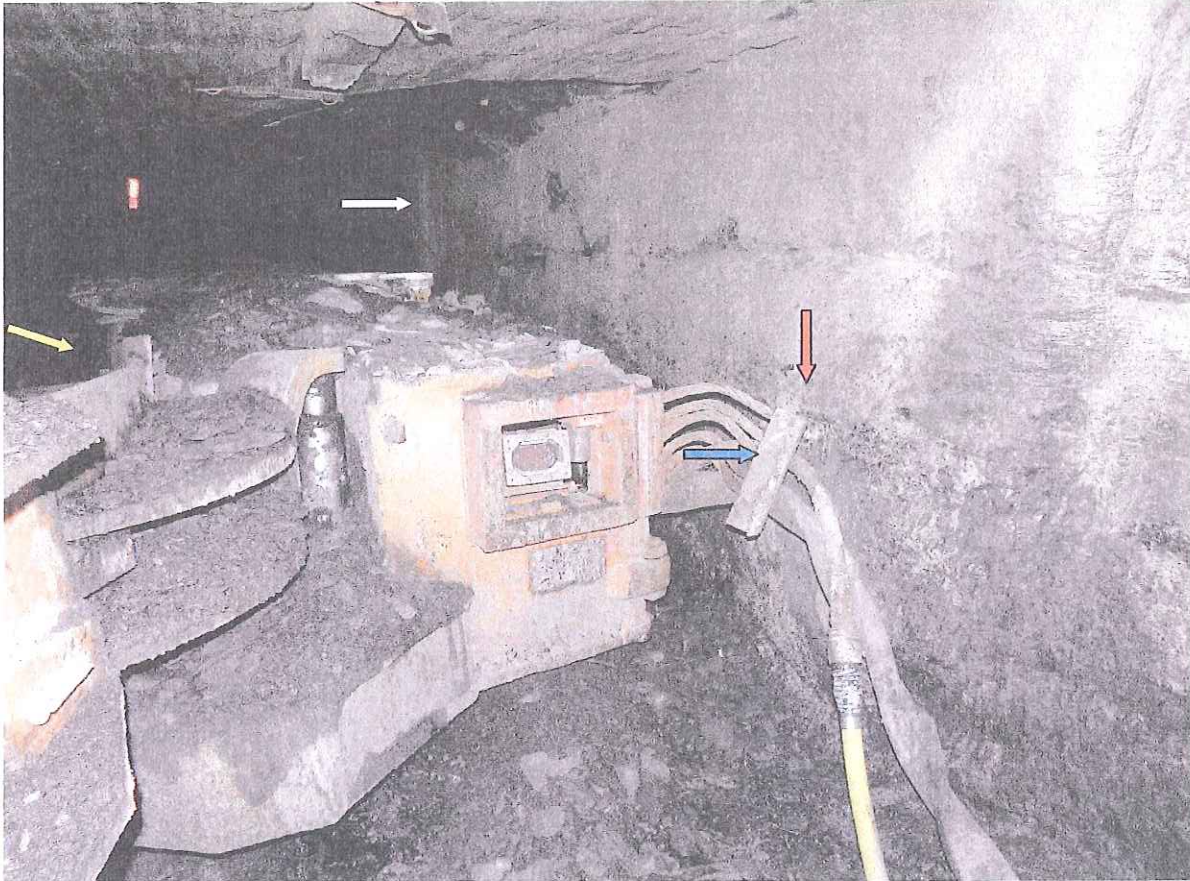
ACCIDENT SCENE
NO. 4 ENTRY

RED ARROW INDICATES THE APPROXIMATE LOCATION OF THE VICTIM, BOBBY L. SMITH

YELLOW ARROW INDICATES THE CONTINUOUS MINER

BLUE ARROW INDICATES THE ELECTRICAL SUPPLY CABLE'S
METAL RESTRAINING CLAMP (ATTACHED TO THE CONTINUOUS MINER);
THE CLAMP STRUCK THE VICTIM AND PINNED HIM AGAINST THE COAL RIB

WHITE ARROW INDICATES AN OFFSET THAT WAS PRESENT IN THE RIGHT COAL RIB
